Project No. 2023-159
Date: 2024-01-17

**Re: Structural Condition Review for Occupant /Worker Safety
Knights Hall Building
King Street, Cranbrook, BC**

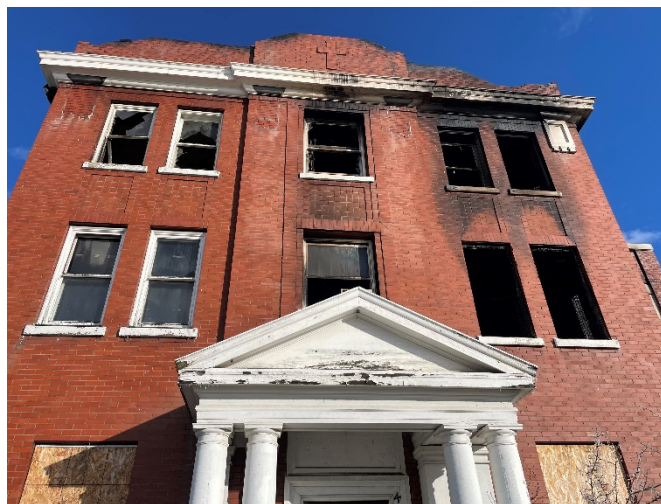
Photograph 1: Exterior Overall View

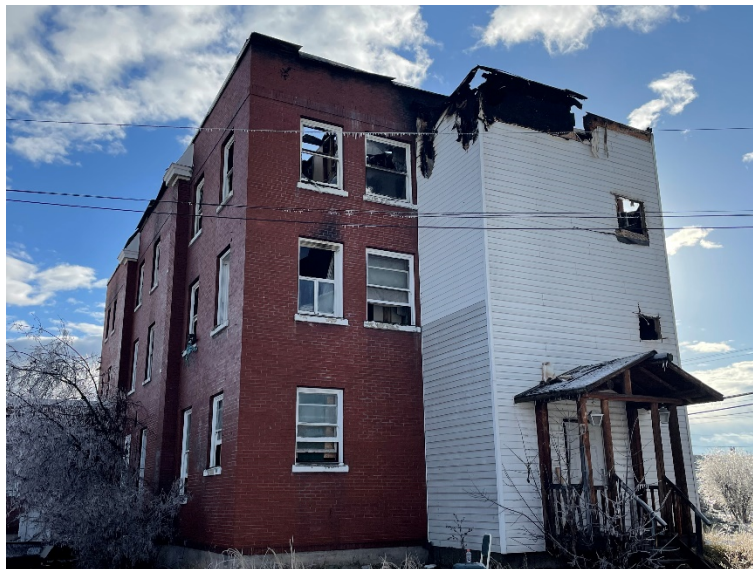
Photograph 2: Building Exterior Overview

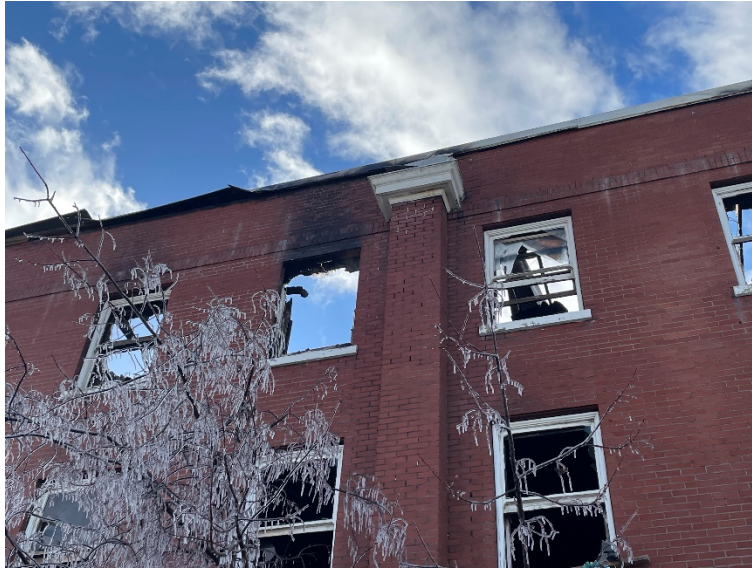
Photograph 3: Exterior View of 3rd Floor Area

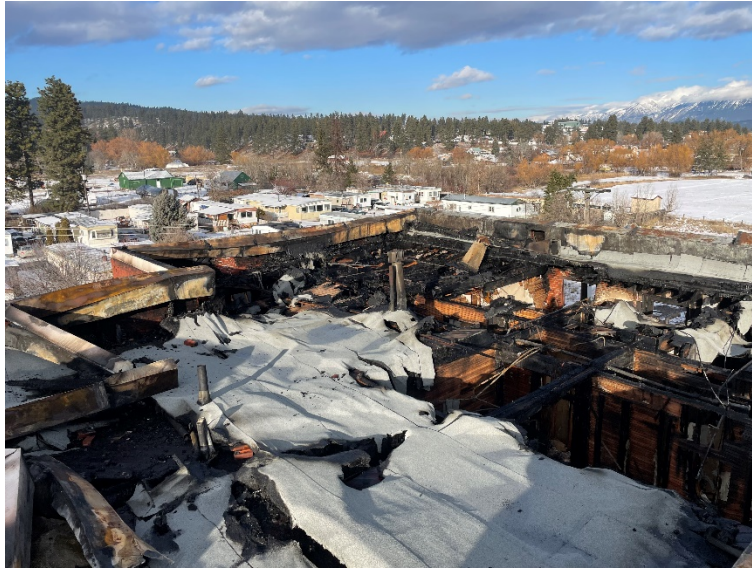
The existing roof system of the building was observed to be nearly completely collapsed throughout the building. In areas where the roof had not collapsed fully the roof structure was observed to be severely damaged with charred and broken roof members and deflecting roof surfaces. Around the perimeter of the roof a parapet exists which originally closed in the edge of the roof framing. The parapet is also clad with brick masonry and was originally supported at the top and bottom by the roof structure. With the roof framing gone, the parapet is no longer laterally supported at the top or bottom and was observed to be deflecting out of plane with portions of the brick showing step cracks and loose and fallen bricks.

Photograph 4: Aerial View of Building Roof System

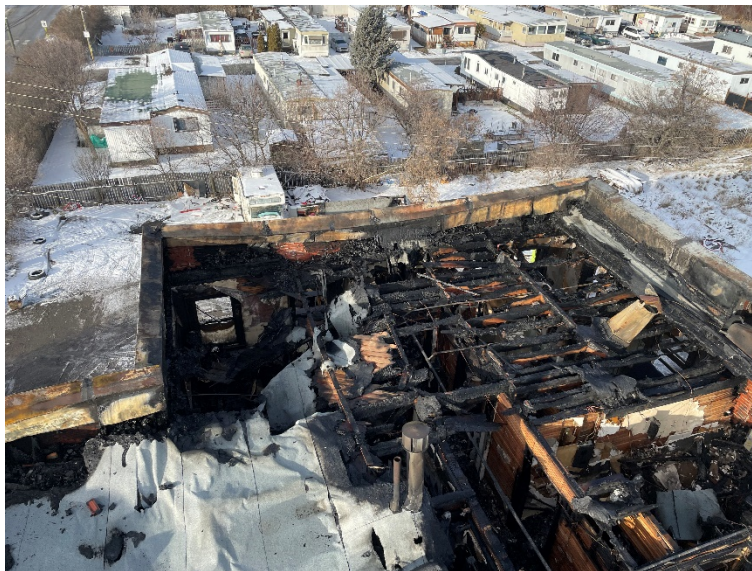
Photograph 5: Damaged and Collapsed Roof Components

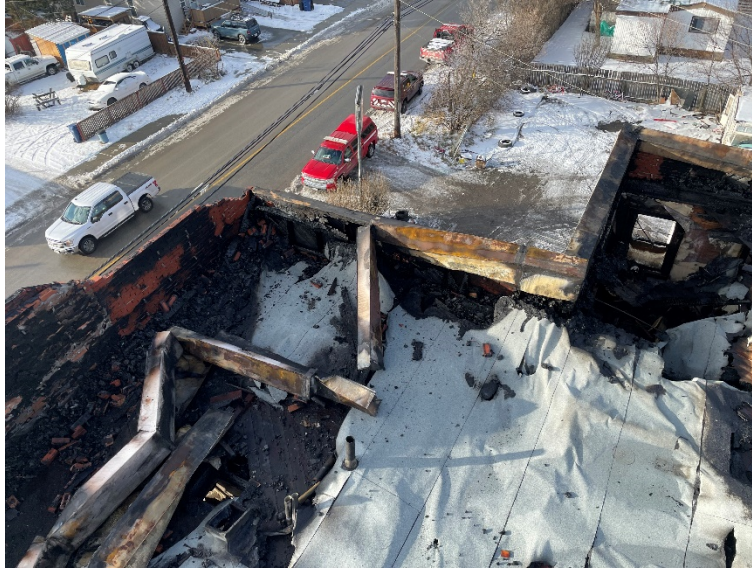
Within the 3rd floor area, the exterior walls have suffered extensive damage due to the recent fire with varying degrees of damage observed around the building. In some areas, smoke damage and charring were observed and in other locations the wall framing has been destroyed completely, leaving only the exterior brick façade in place. Signs of

structural distress and damage were observed within the exterior walls in the form of step cracking in the exterior masonry surface, freshly broken and cracked bricks, crumbling brick mortar, deflecting wall surfaces, and leaning walls.

Photograph 6: Exterior Walls and Parapet

In addition, the lack of support of individual components of the building presents a cause for concern. The collapse of the roof structure has eliminated the lateral support of the 3rd story walls and roof parapet above. As such, these walls and their brick façade have become extremely unstable, and collapse of these components is highly probable in the immediate future.

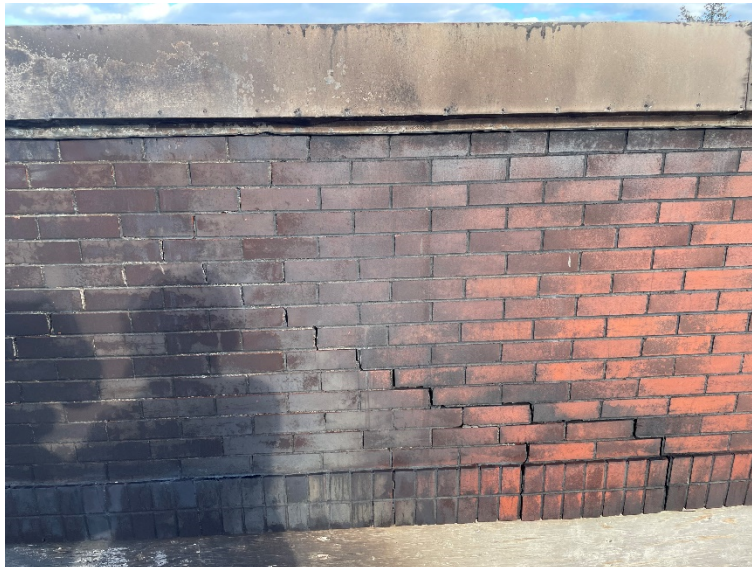
Photograph 7: Wall Facade Step Cracking

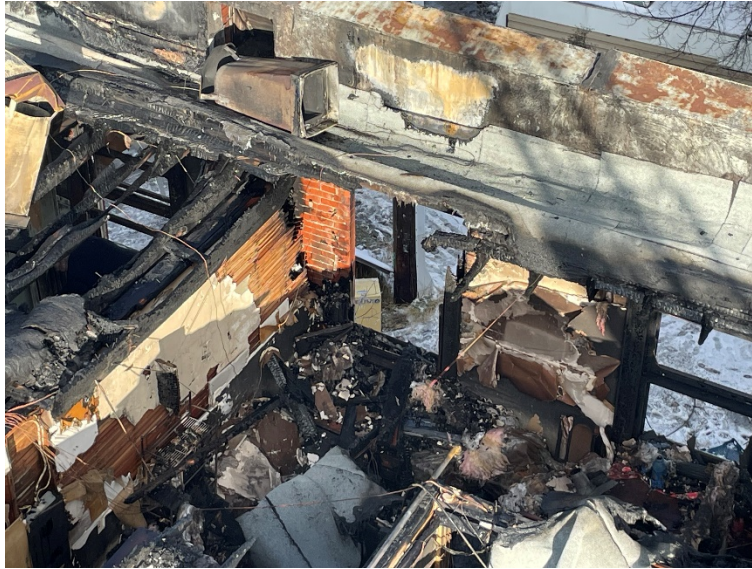
Photograph 8: Exterior Wall Damage

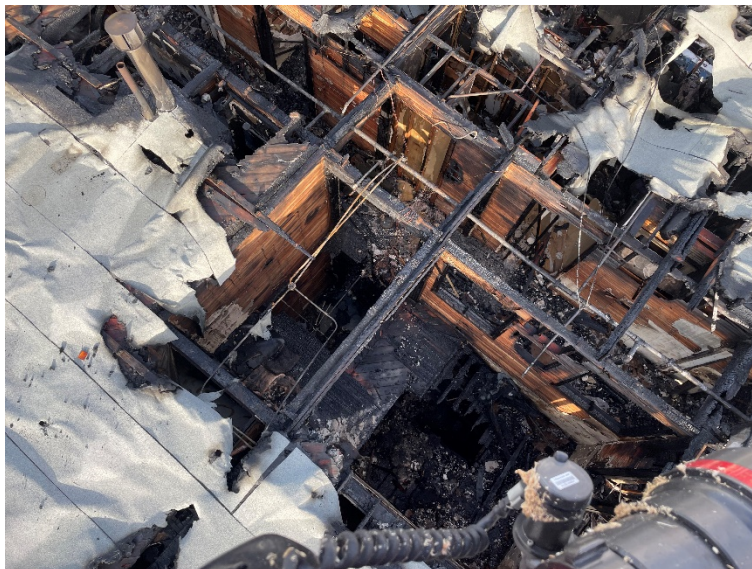
The 3rd floor framing that was able to be viewed appeared to have suffered fire damage in numerous locations, most extensively around the building stairwell. The damage observed consisted of smoke damage, charring and complete collapse in various areas around the building.

Photograph 9: Roof and 3rd Floor Damage at Stairwell

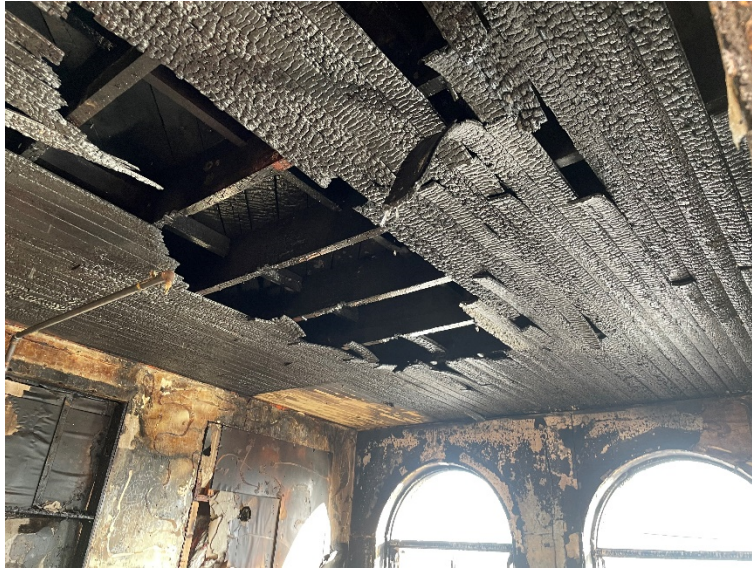
Photograph 10: 3rd Floor System Damage

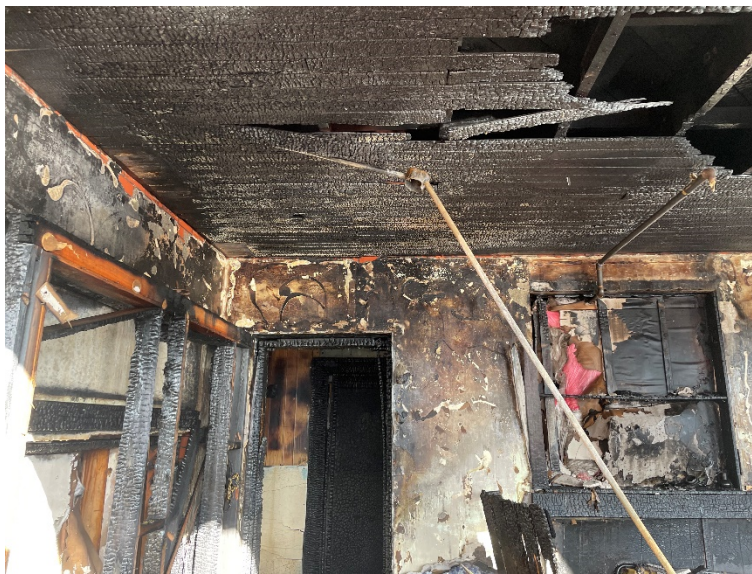
Photograph 11: 3rd Floor Framing Damage

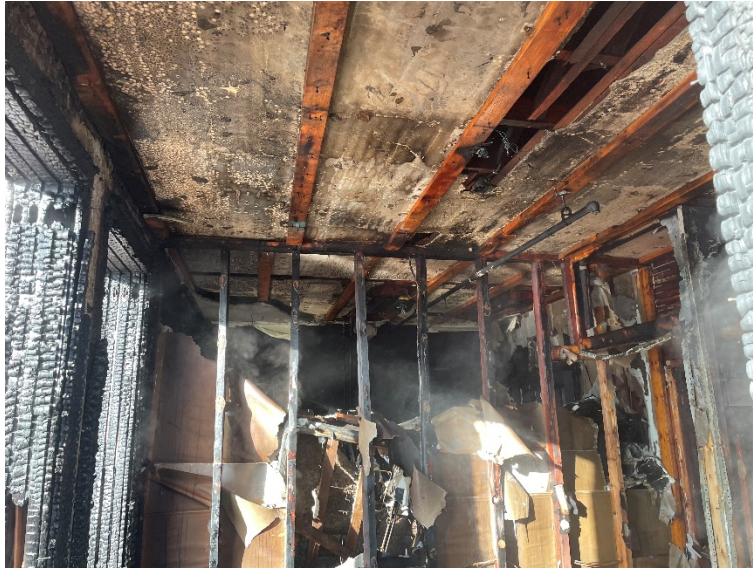
The 2nd floor framing that was mostly concealed and unable to be reviewed though in some locations visible via exterior windows, the floor framing did appear to have suffered fire damage. The damage observed consisted of smoke damage and charring in various areas around the building.

Photograph 12: 2nd Floor Area

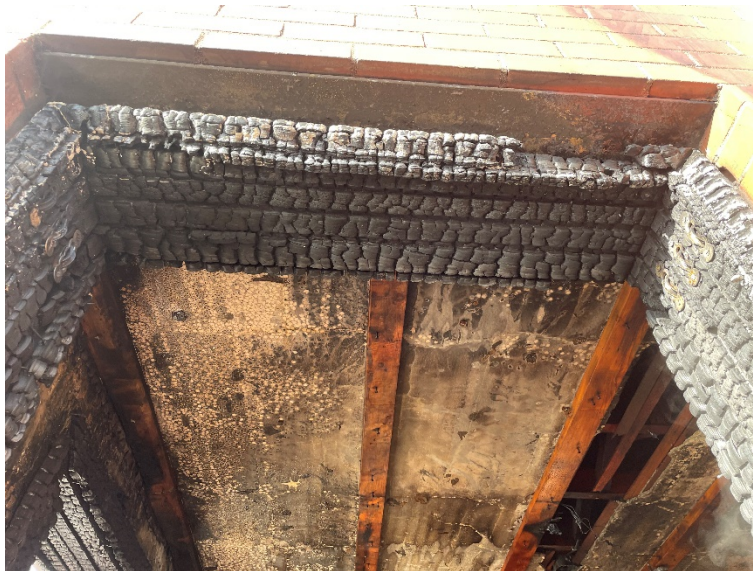
Photograph 13: 2nd Floor Window Damage
