City of Cranbrook 40 – 10<sup>th</sup> Avenue Cranbrook, BC V1C 2M8 Project No. 2023-130 Date: 2023-10-16

Re: Feasibility Review of Structural Repairs Cranbrook Memorial Arena 1432 2<sup>nd</sup> Street North, Cranbrook, BC

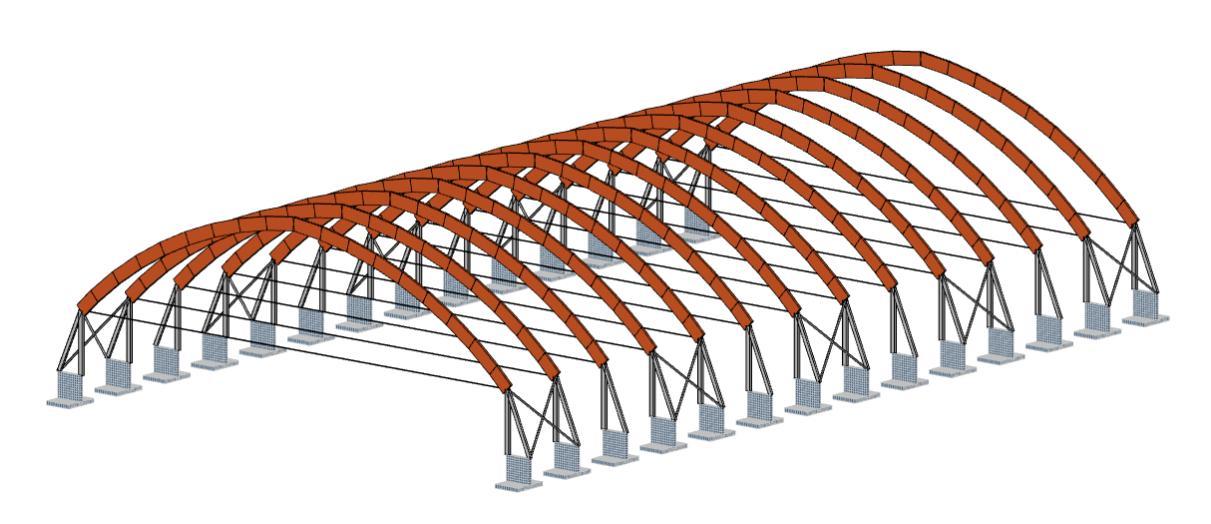
Figure 1: Conceptual Structural Repair Option

A conceptual structural repair plan for the building was developed by Bolen Engineering with the intent of removing the existing deteriorated portions of the glulam arches, reinstating the structural integrity of the building structure, and incorporating a structural repair which could be installed minimal impact to the existing building layout. A preliminary 3D model of the conceptual structural repair developed by Bolen Engineering is shown below in Figure 1.
